Facility Condition Assessment

Clayville Elementary School | *October 2016*

Address: 3 George Washington Highway, Clayville, RI 02815

Clayville Elementary School Condition Assessment

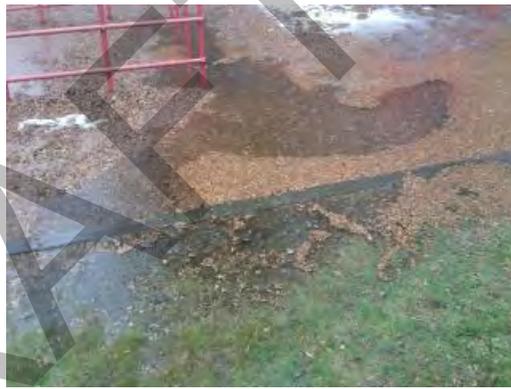
Ponding In Play Area

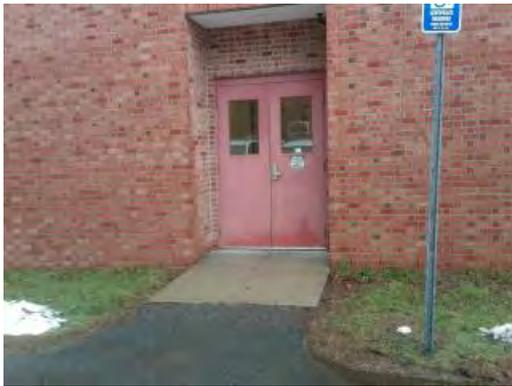
Faded Exterior Door Paint

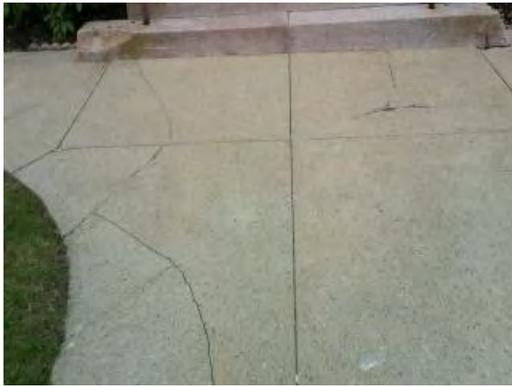
Cracked Sidewalk

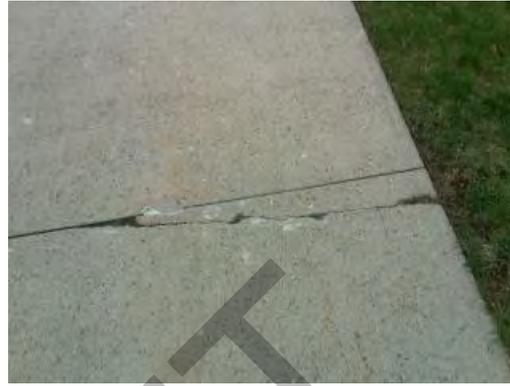
Cracked Sidewalk

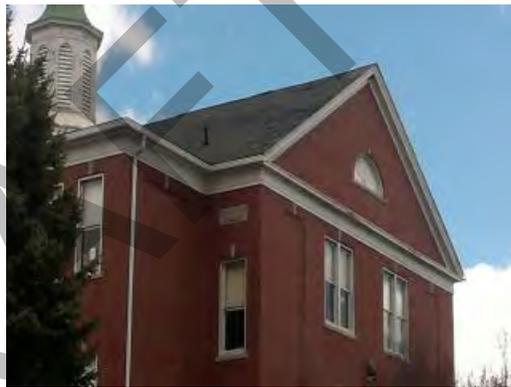
Aged Shingle Roof

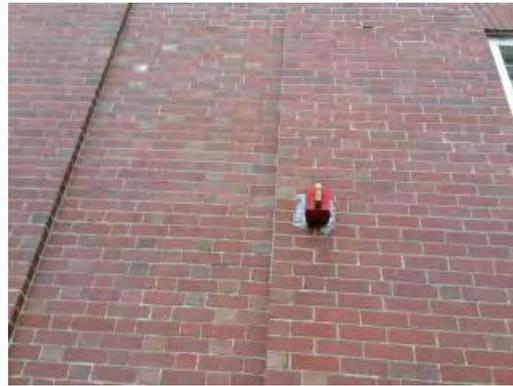
Damaged Horn Strobe

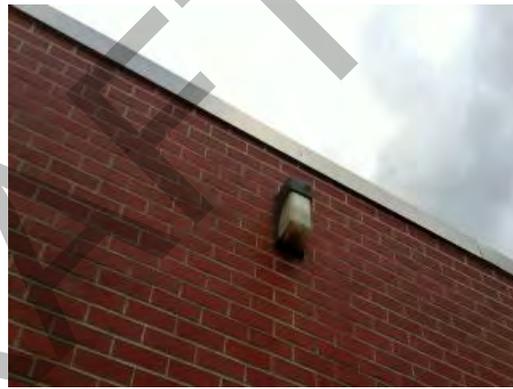
Damaged Light

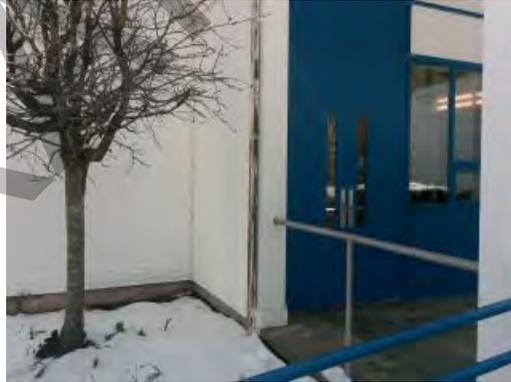
Damaged Downspout

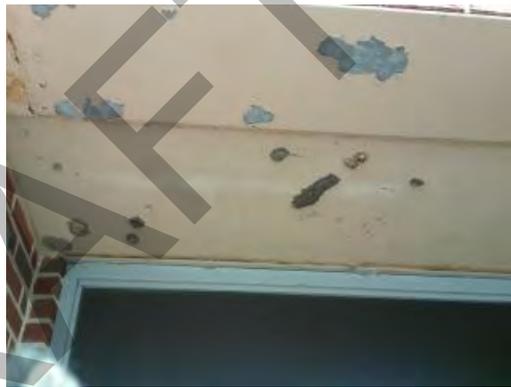
Damaged Soffit

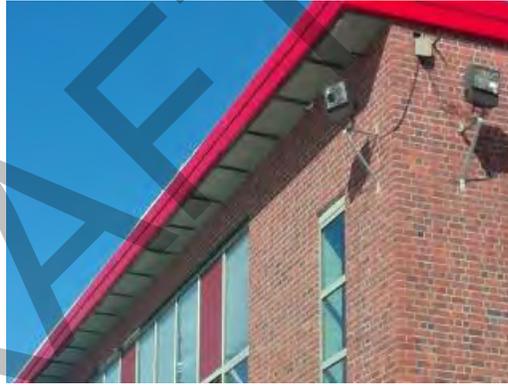
Worn Soffit Paint

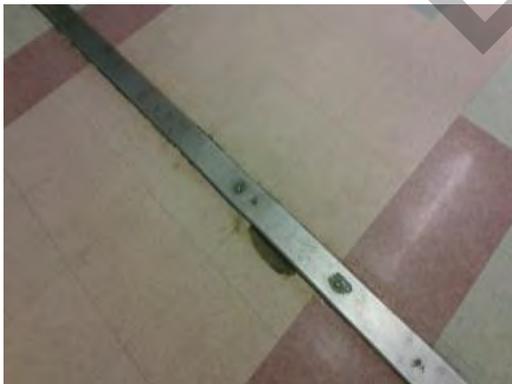
Lifted Joint Cover With Damaged VCT

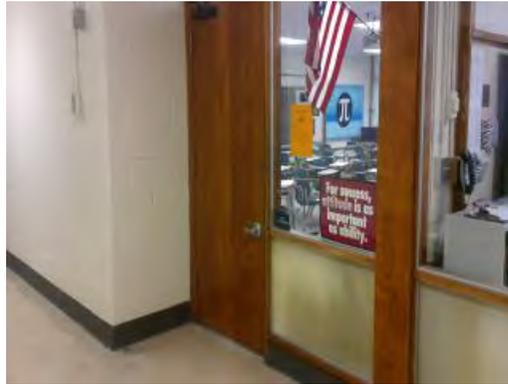
Non-Compliant Door Hardware

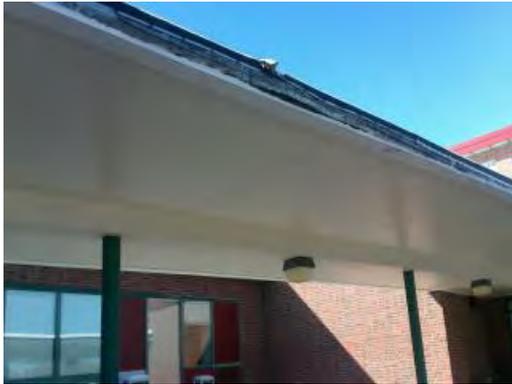
Damaged Canopy Roof Edge

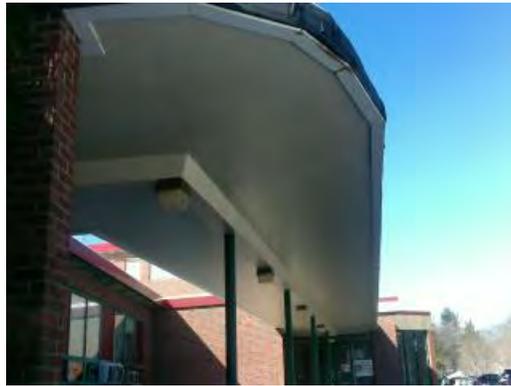
Damaged Canopy Roof Edge

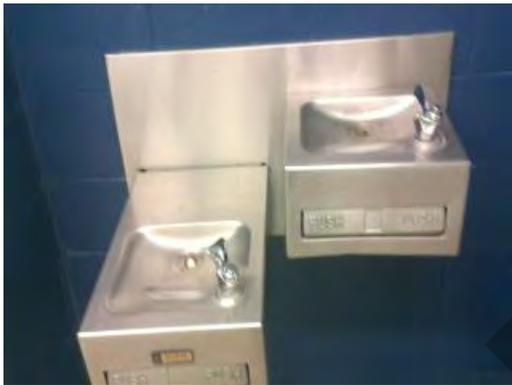
Damaged Drinking Fountains

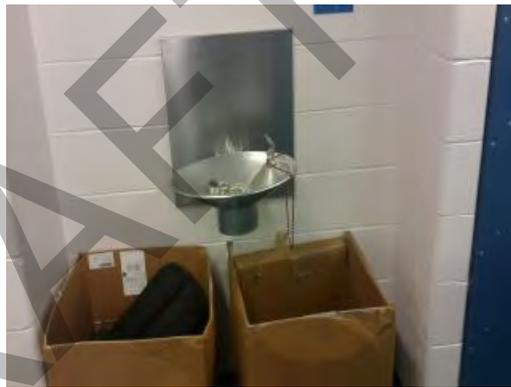
Non-Functional Drinking Fountain

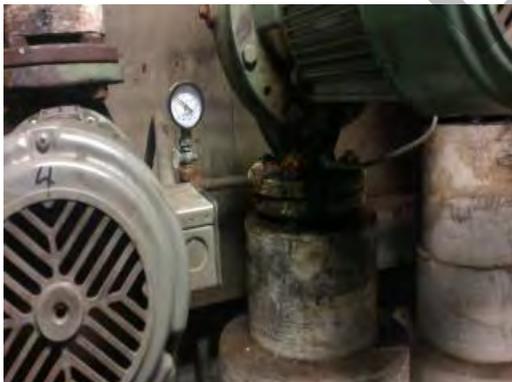
Corroded Pumps

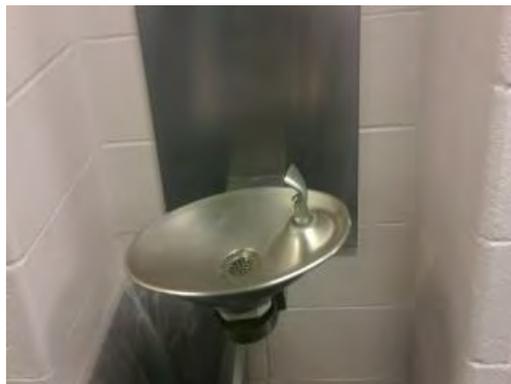
Non-Functional Drinking Fountain

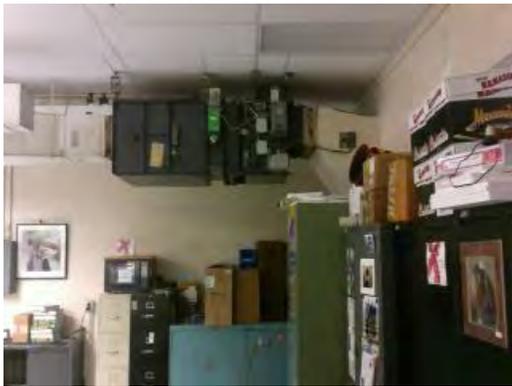
Aged Air Handler

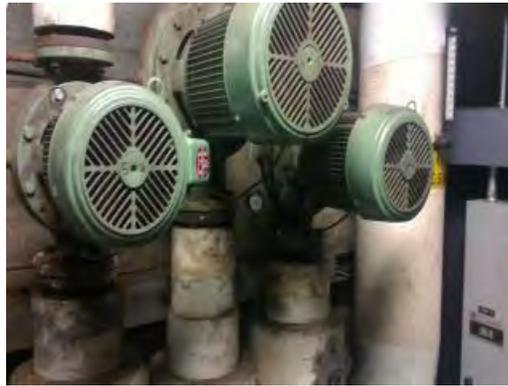
Corroded Pumps

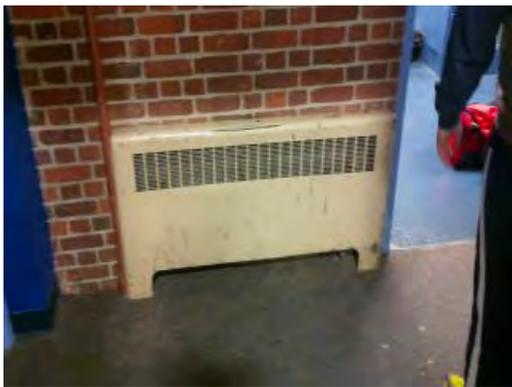
Typical Deteriorating Radiant Heater

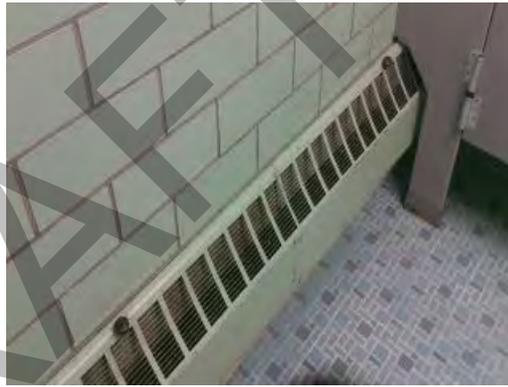
Typical Aged Radiant Heater

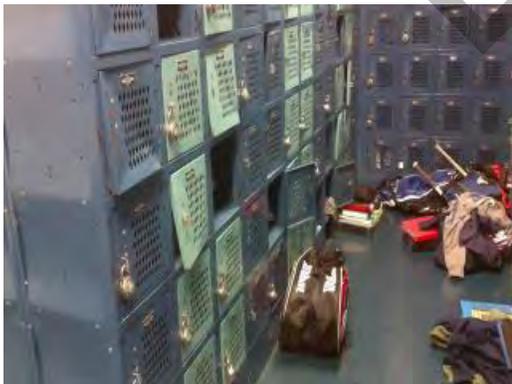
Damaged Lockers

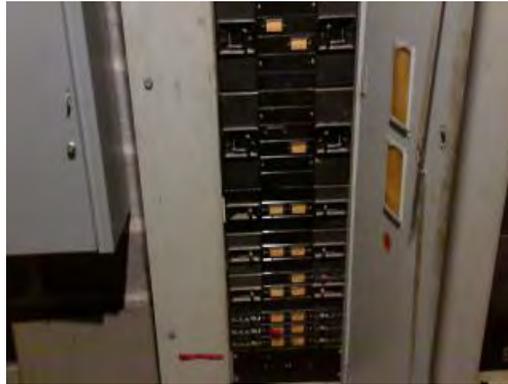
Aged Distribution Panel
