Facility Condition Assessment

Clayville Elementary School | *October 2016*

Address: 3 George Washington Highway, Clayville, RI 02815

Clayville Elementary School Condition Assessment

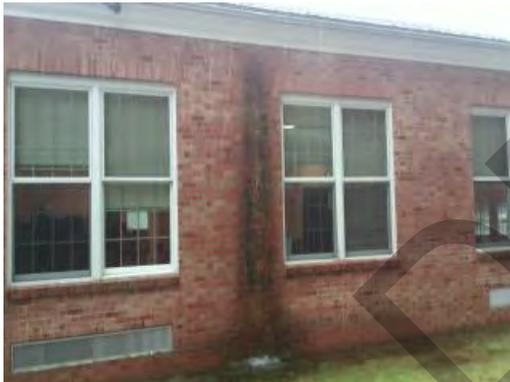
Water Draining Down Wall Face

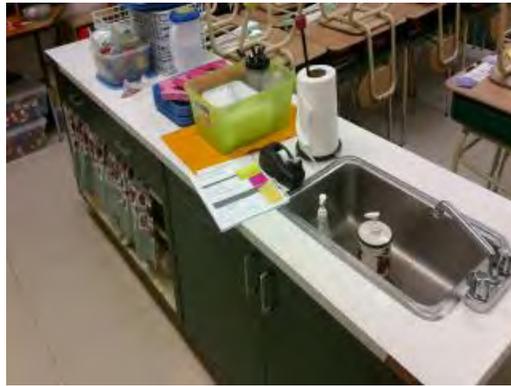
1975 Casework

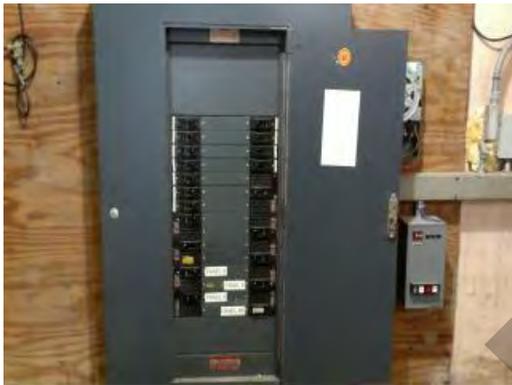
Original 400A Distribution Panel

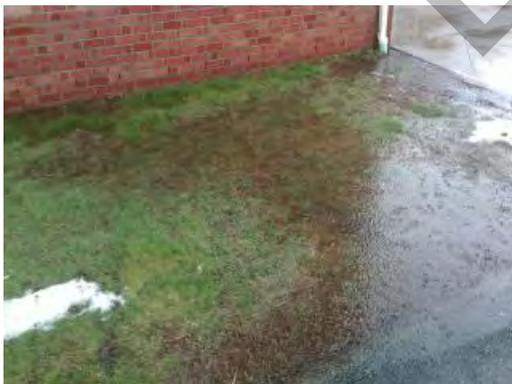
Ponding At East Side Of Building

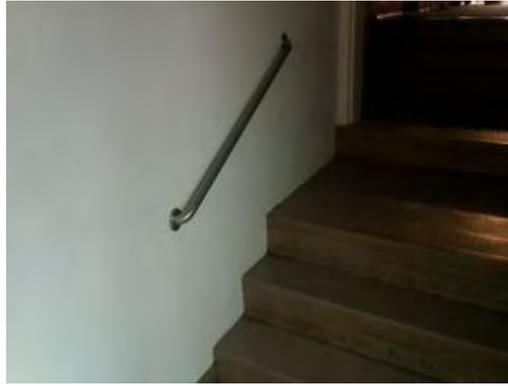
Non-Compliant Handrails

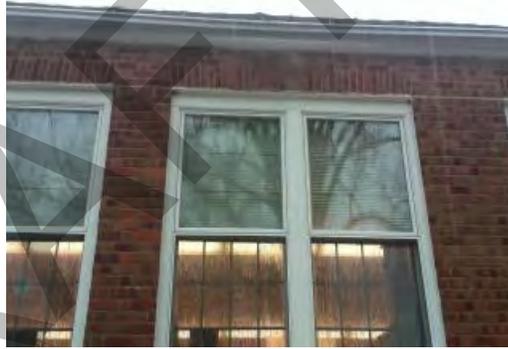
Typical Gutter With Debris

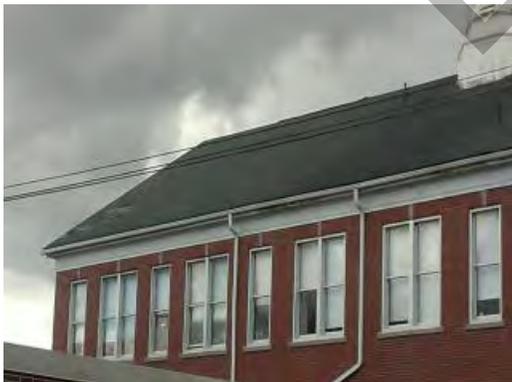
Aged Shingle Roof

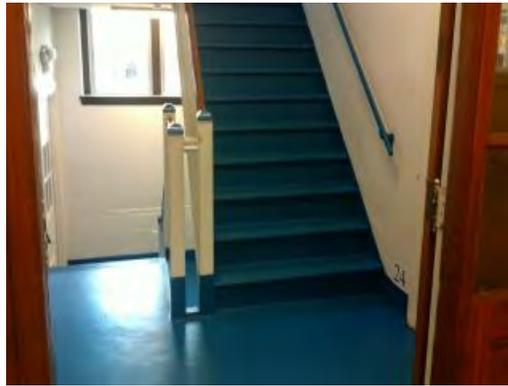
Non-Compliant Handrail

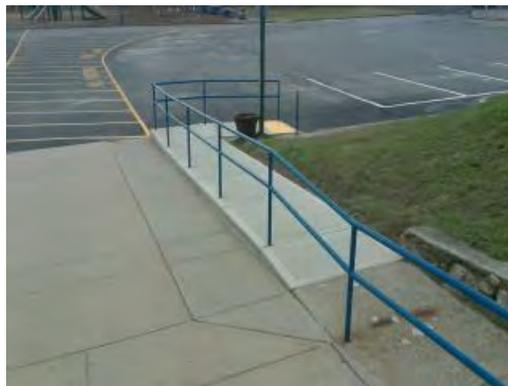
Non-Compliant Ramp

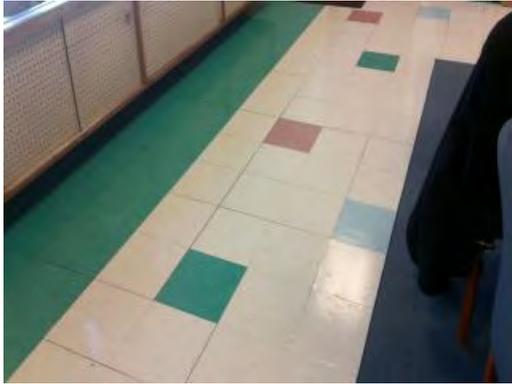
Separating VCT In Classrooms

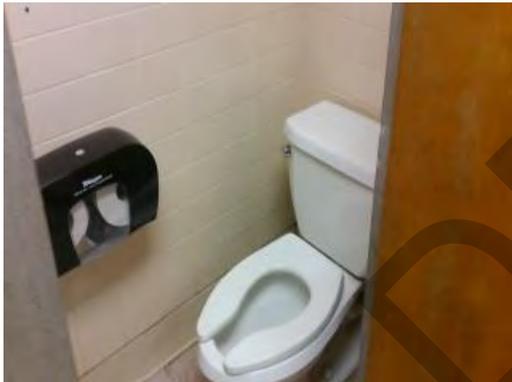
Non-Compliant Restroom

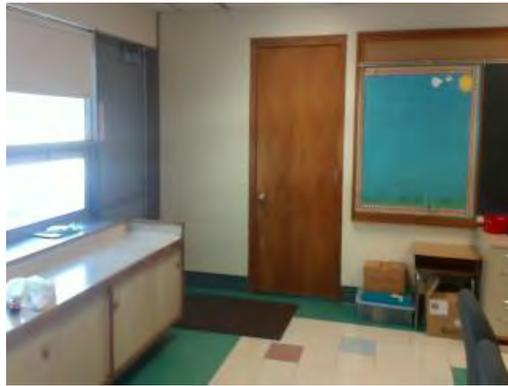
Non-Compliant Door Hardware

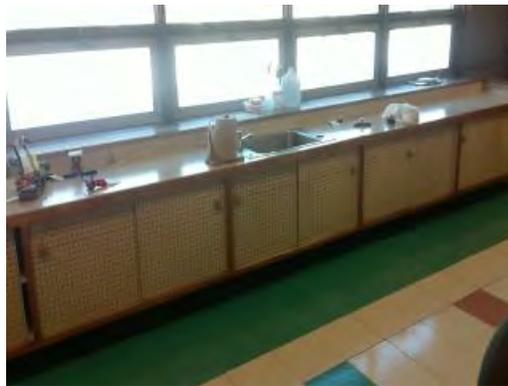
Aged Casework

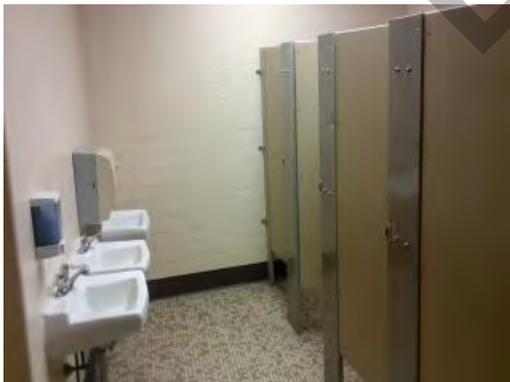
Restroom Fixtures And Finishes

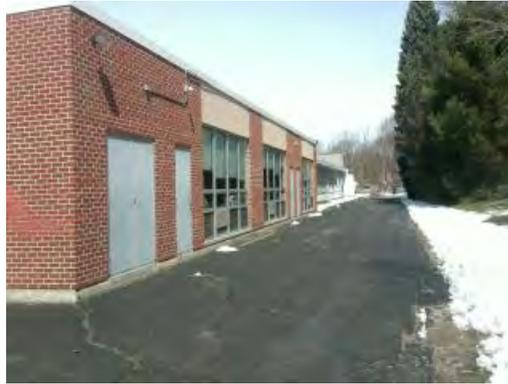
Exterior Finishes

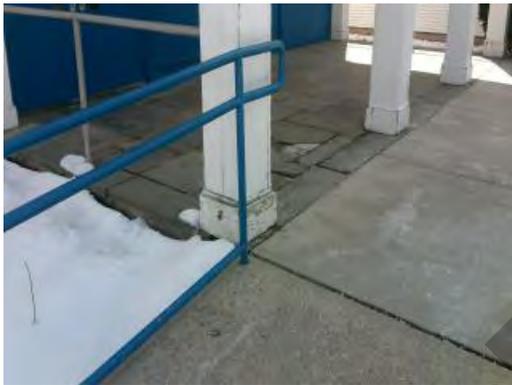
Wood Column Base

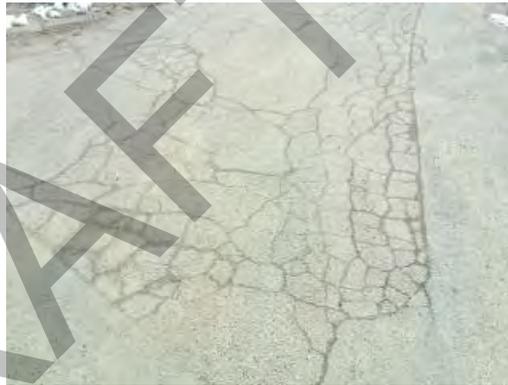
Alligatored Asphalt

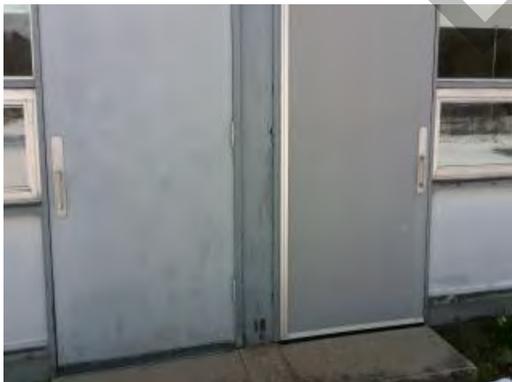
Faded Exterior Door Paint

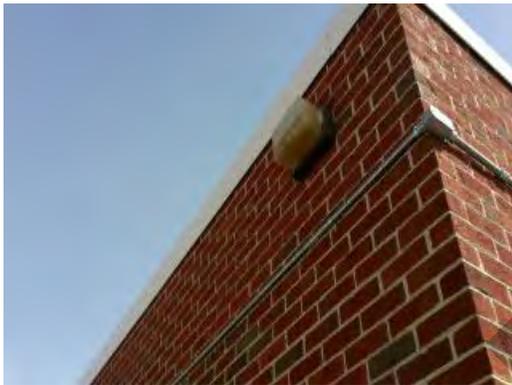
Aged Wall Pack

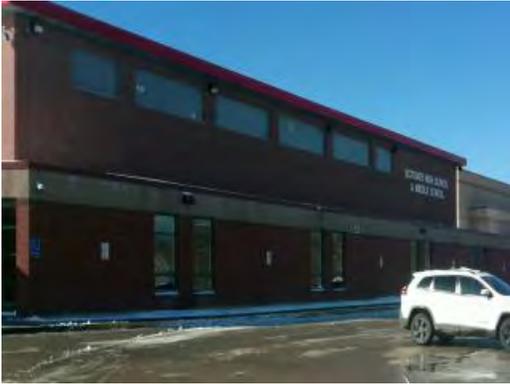
Exterior Finishes

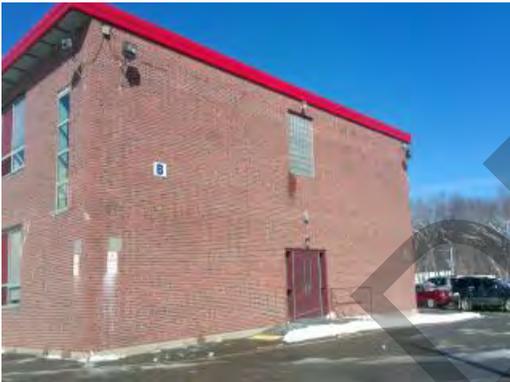
Exterior Brick

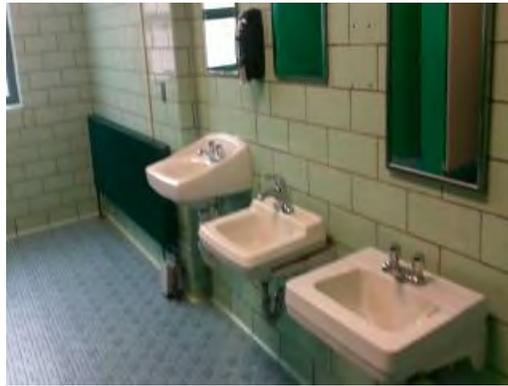
Typical Restroom Lavatories

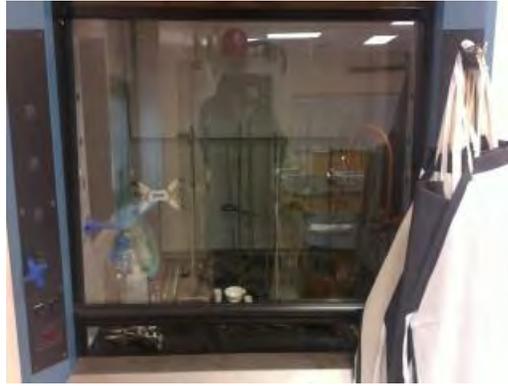
Outdated Fume Hood

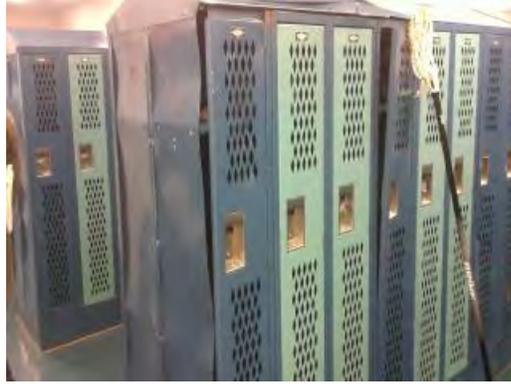
Dented Lockers
